THE EFFECT ON BLADE EROSION OF INJECTING AIR AHEAD OF A CAVITATING PROPELLER

**DAVID W. TAYLOR NAVAL SHIP
RESEARCH AND DEVELOPMENT CENTER**

✓ SHIP PERFORMANCE DEPARTMENT
DEPARTMENTAL REPORT

March 1980

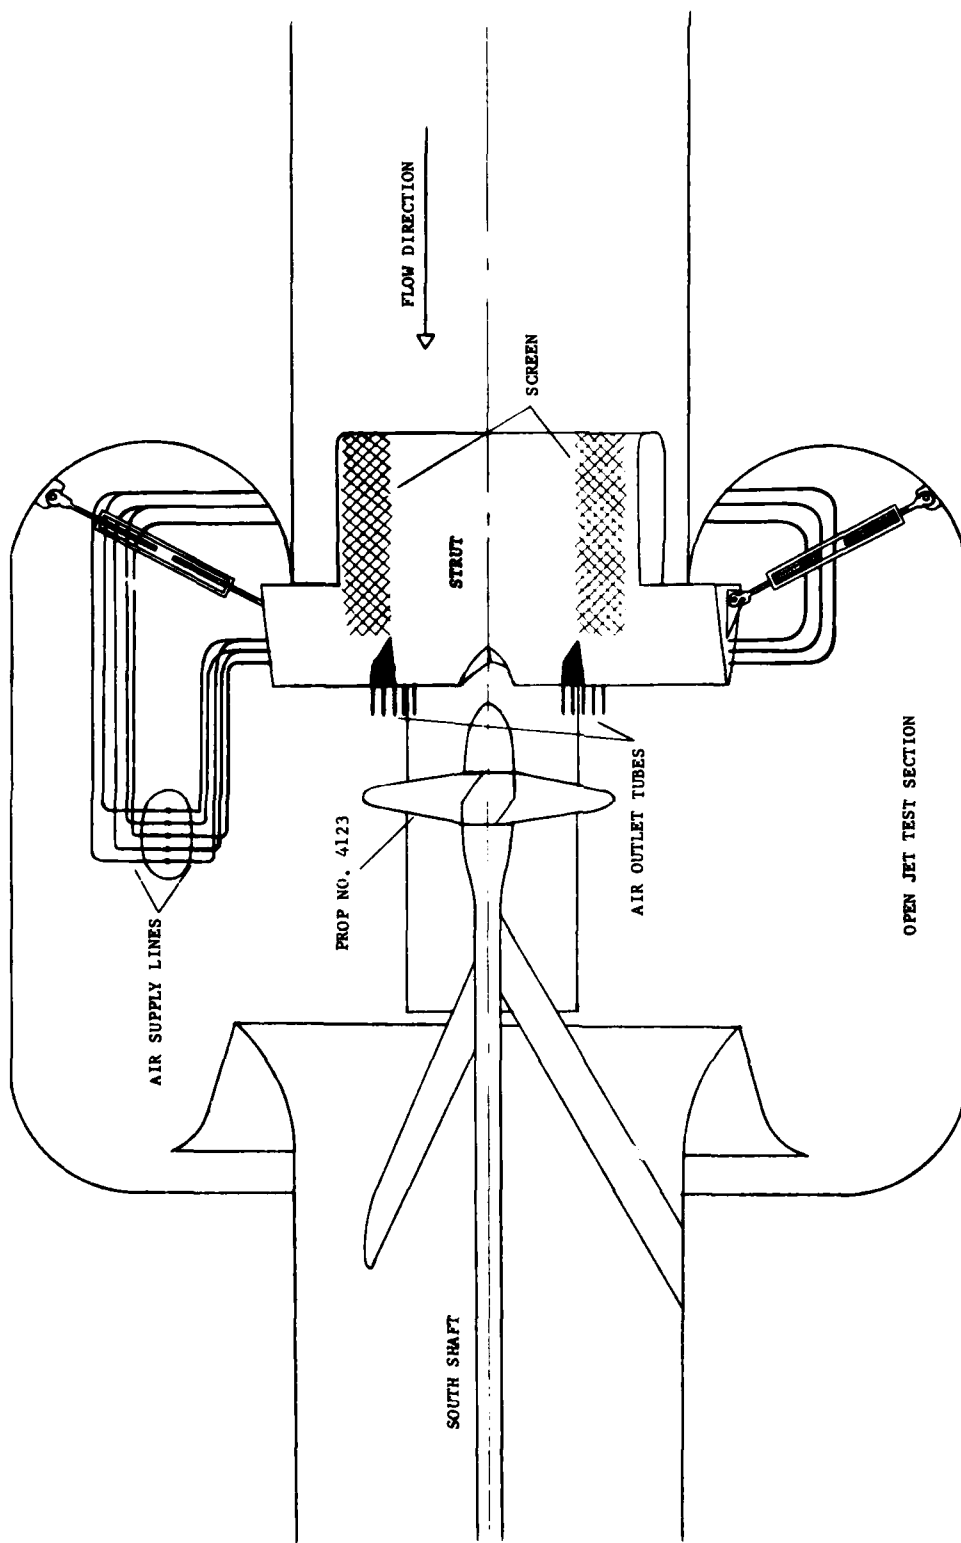
Figure 1 - Sketch of the 36-Inch Water Tunnel Open Jet Test Section With the Strut, Air supply System and Propeller Installed

All experiments were conducted in the 36-inch water tunnel facility at DTNSRDC. The test arrangement consisted of a strut installed in the open jet test section of the tunnel ahead of a two-bladed propeller (Figures 1 and 2). Air was emitted from tubes located on the trailing edge of the strut.

The paint erosion test described earlier was conducted and the propeller was removed and the pressure gages and inserts were installed. All the remaining runs were 10 minutes in duration with the discs in place, the only exception being the run with the bronze disc No. (1) which ran for 5 hours 42 minutes. Table 2 presents a list of all test conditions. Air was supplied at a pressure of 40 psia for all portions of the experiment when air was emitted. The location and the numbering scheme for the air tube pairs is shown in Figures 1 and 2.

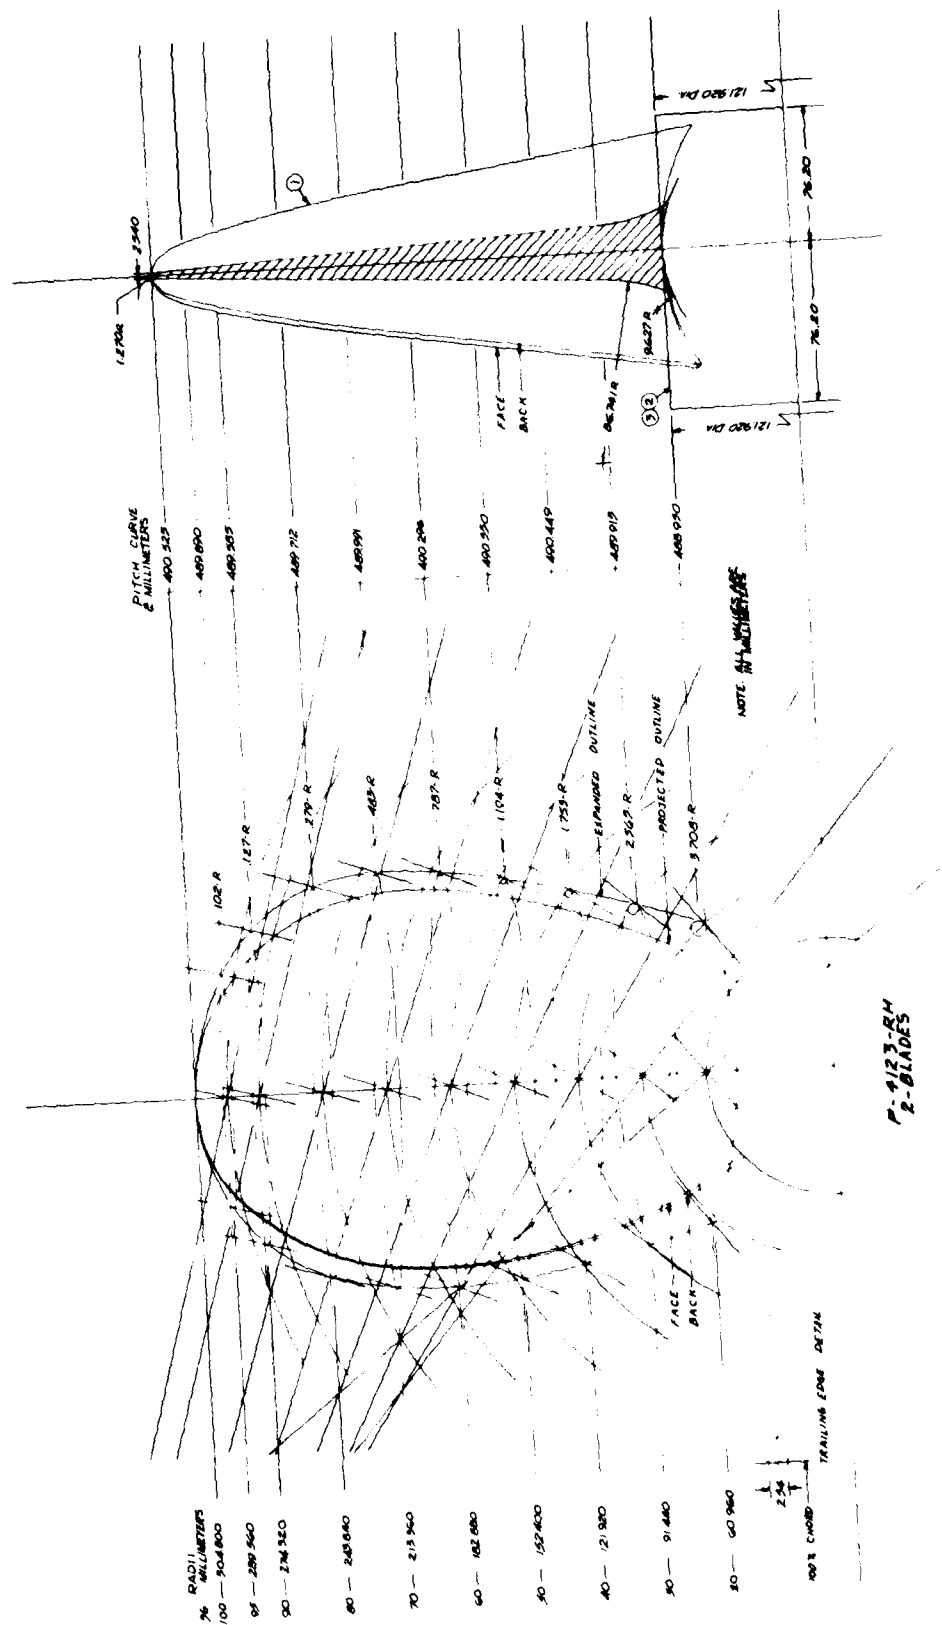
Figure 3 - Drawing of Propeller 4123

The propeller used in these experiments was DTNSRDC Propeller No. 4123. The propeller has two blades and is 24-inches (0.61 m) in diameter. A drawing and table of the geometry of the propeller are presented in Figure 3 and Table 1, respectively. Pressure gages were installed on the back of one blade and soft aluminum inserts were installed on the back of the other to reduce the time required to produce erosion. The locations of the gages and inserts are shown in Figure 4. Recesses for pressure transducers and/or strain gages which had been used in previous, unrelated experiments can be seen in the photograph. These were filled with an epoxy compound for the present tests. The method used to select the locations of the inserts and gages will be discussed later.

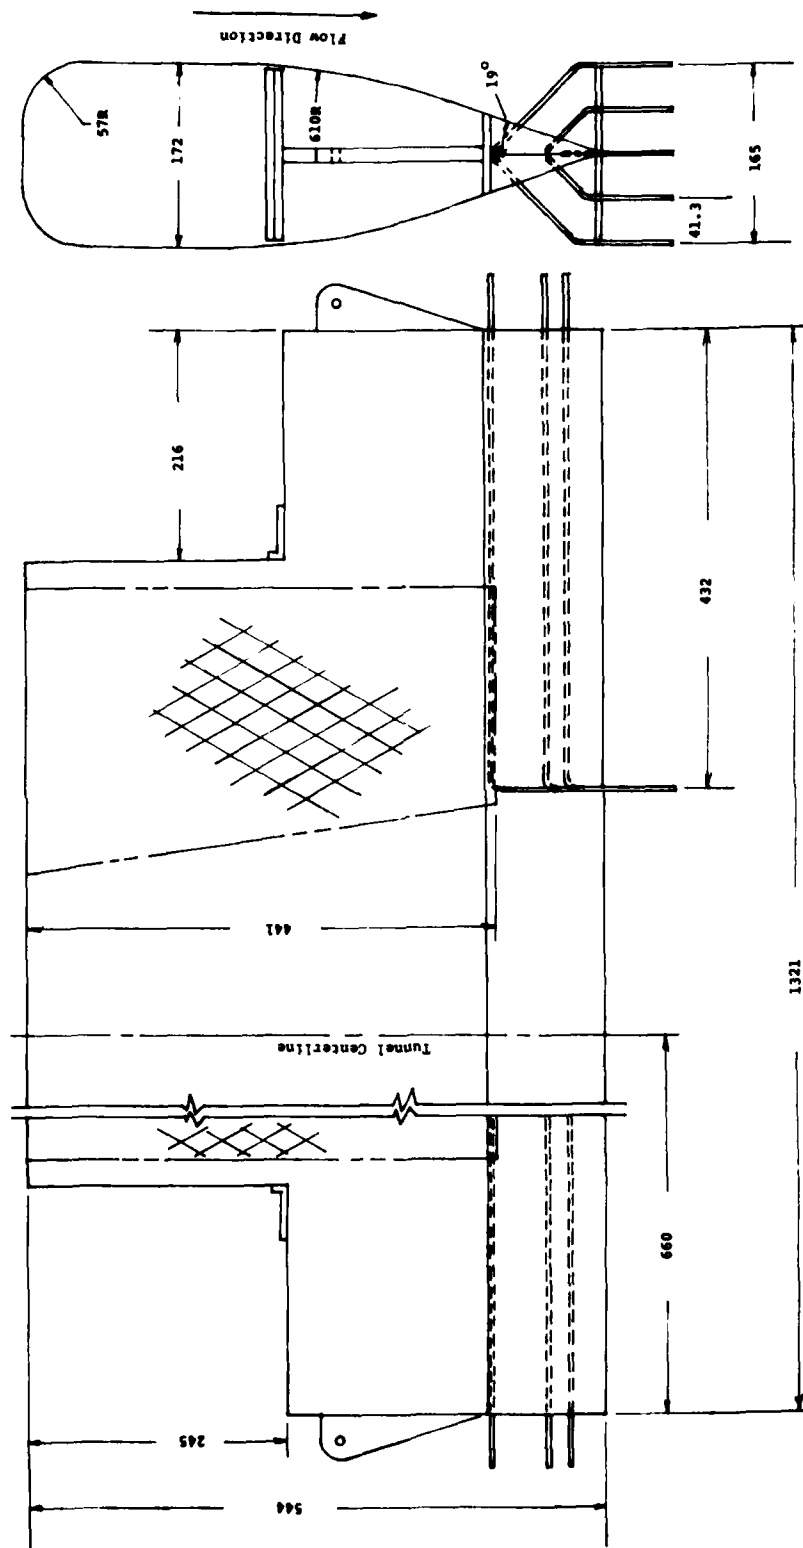
NOTE: All Dimensions are in Millimeters

Figure 5 - Drawing of the Strut

A strut was placed ahead of the propeller to produce a nonuniform wake. The strut is a scaled version of a smaller strut used in the 24-inch water tunnel at DTNSRDC. A drawing of the strut is presented in Figure 5. Expanded metal screening was installed on the strut surface to roughen the surface and produce a stronger wake. The location of

the screening is shown in Figure 5. A notch was cut out in the center of the strut to facilitate removal of the fairwater.

Brass tubes were installed in the strut to perform the air emission ~~portion of the~~ experiments. Five tubes were arranged in a rake configuration and were equally spaced 1-5/8 inches (41.3 mm) apart as shown in Figure 5. Two sets of tubes were installed on both sides of the strut such that the tube planes were tangent to the 0.75 radial section of the propeller (also shown in Figure 5). The air was supplied by the pressurized air supply system at the tunnel to the inlet tubes located on both ends of the strut. A flowmeter (rotameter) was inserted in the air circuit so air flow could be measured. Figure 7 presents a schematic of the air emission system.

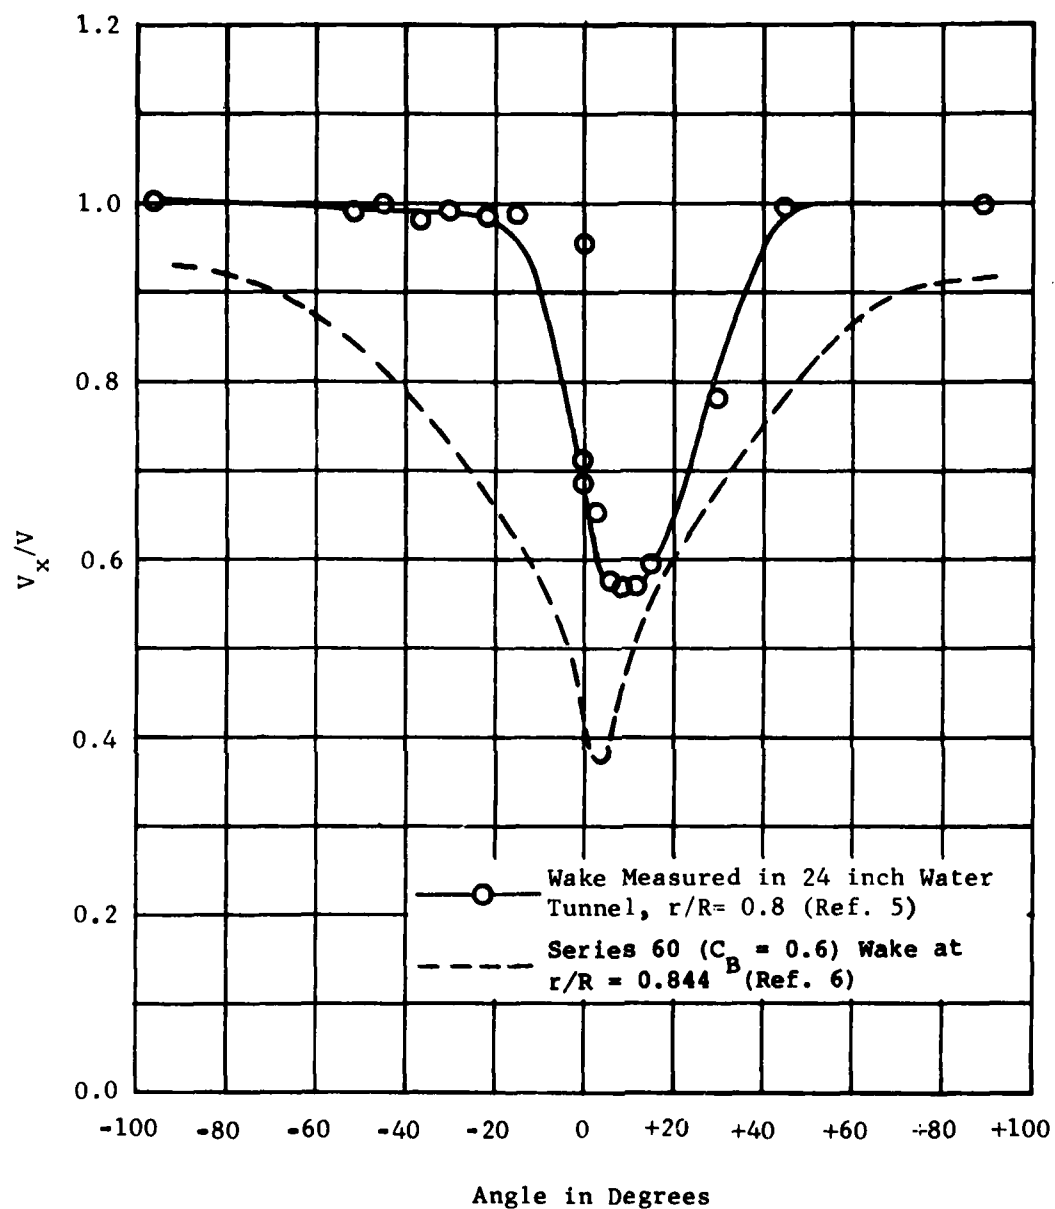
Figure 6 - Comparison of the Circumferential Distribution of Longitudinal Velocity Ratios of a Series 60 Model Hull at $r/R = 0.844$ and the 24-Inch Water Tunnel Model of the Strut at $r/R = 0.8$

Although no wake survey was conducted for the present tests a wake survey was available for the smaller version of the same strut used in the 24-inch water tunnel at DTNSRDC.⁵ The results of that survey at the 0.8 radius are presented in Figure 6. The wake for a series 60 hull form, $C_B=0.6$ at the 0.844 radial position is also shown.⁶ The comparison shows that the wake is similar to a merchant ship wake but not as deep nor as wide.

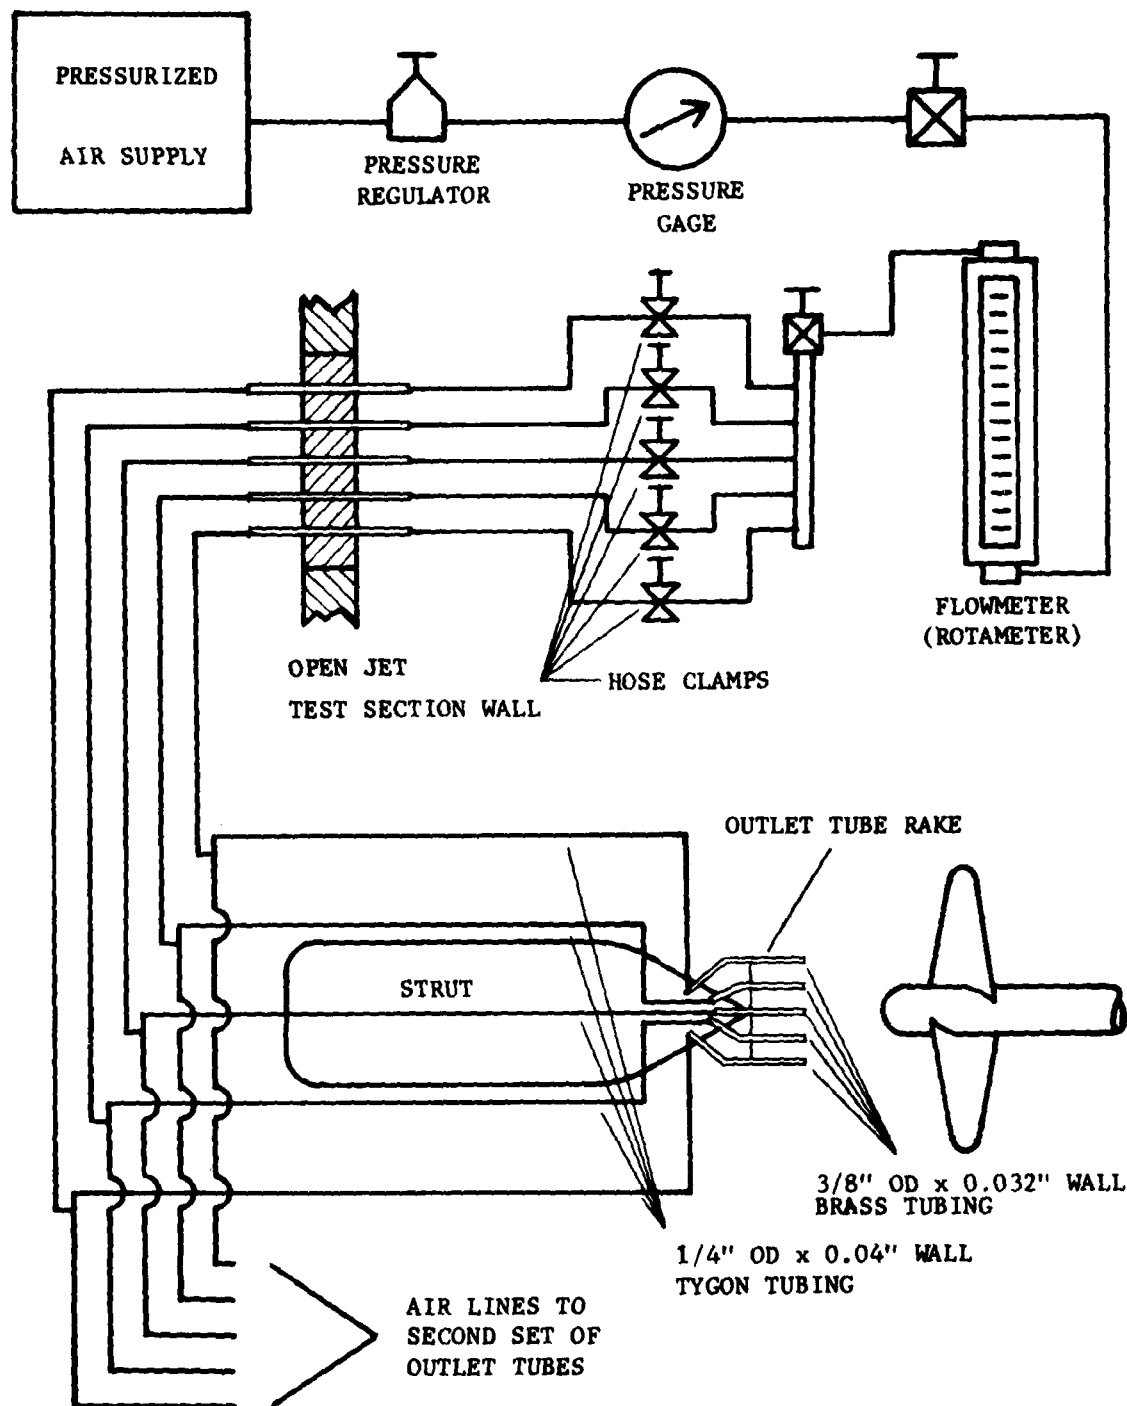
Figure 7 - Schematic of Air Supply System

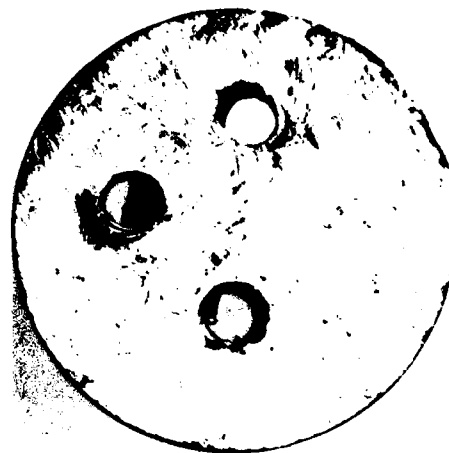
Disc No.9, Tube No.4

Disc No.8, Tube No.5

Disc No.11, Tube No.4, Repeat

Disc No.10, Tube No.4 Reduced Air

Disc No.1, Bronze, Without Air
5 hours, 42 minutes ($\approx 186,000$ cycles)

Figure 13 - Photographs of the Discs Used During the Experiment

Photographs of the 11 discs used during the experiment are presented in Figure 13. Test conditions are described for each disc. Any further references to the discs will be by the numbers assigned to them in the photographs.

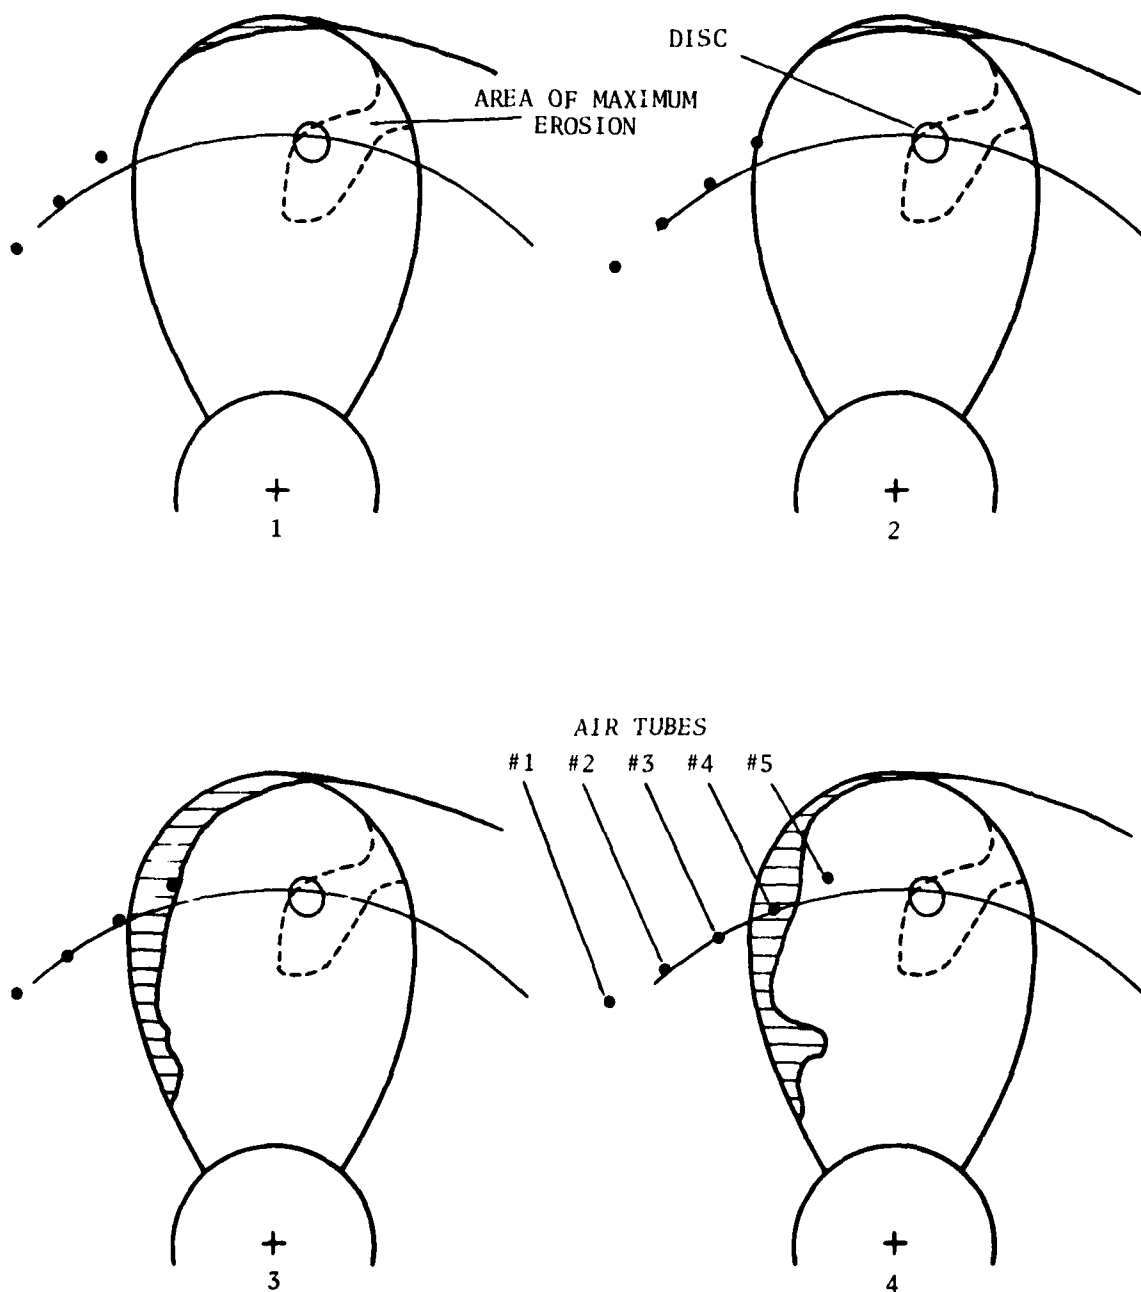
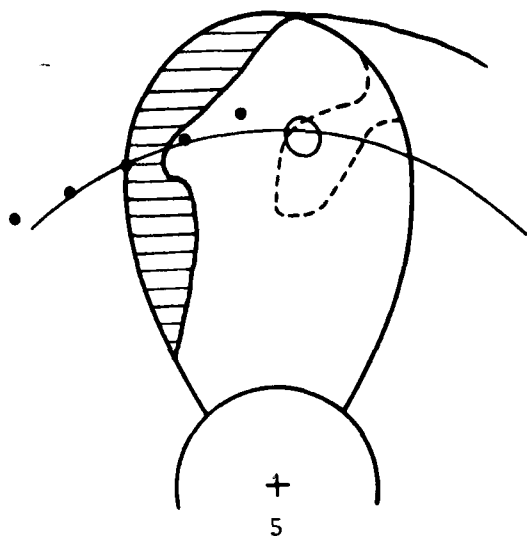
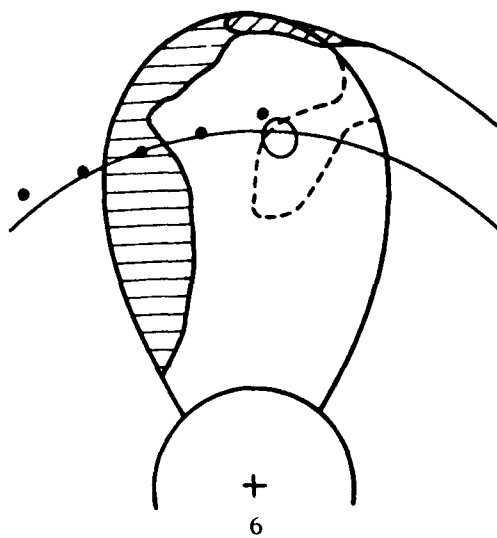
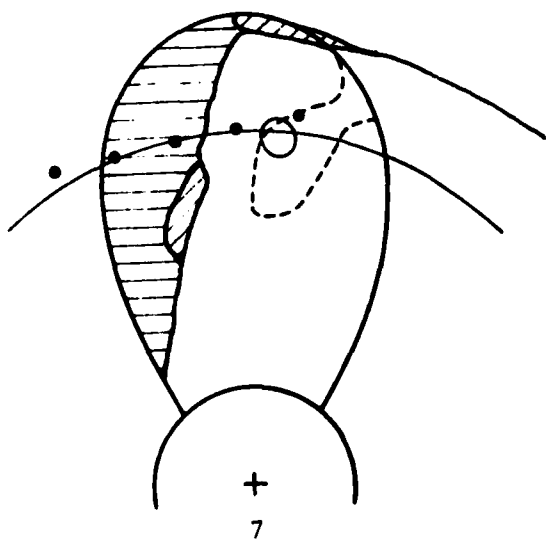
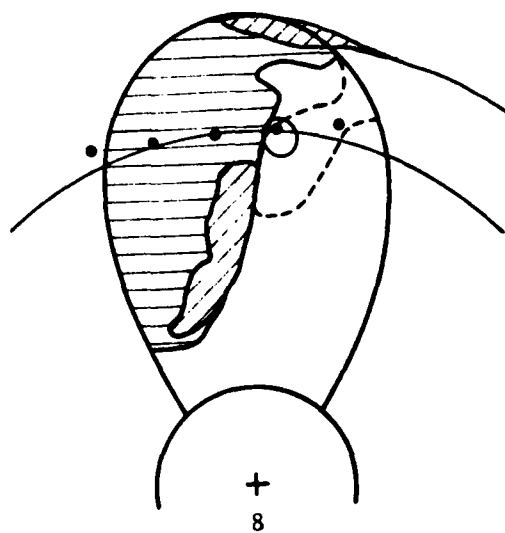
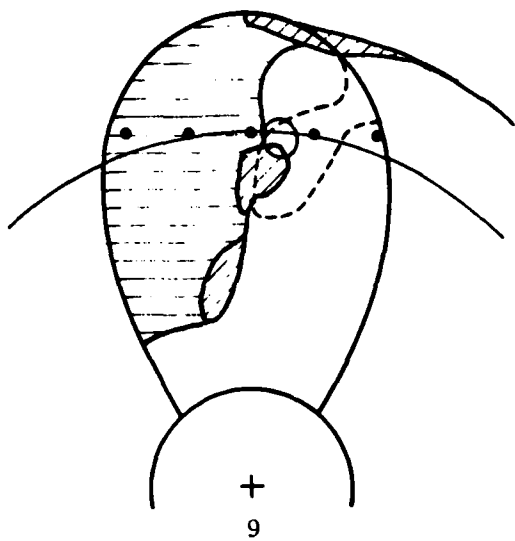
NOTE: Areas filled with horizontal lines denote cavity sheets.
 Areas filled with diagonal lines denote cloud or bubble cavitation.

Figure 14 - Sequential Sketches of the Cavity
 Passing over the Propeller Blade
